# **INDOOR AIR QUALITY REASSESSMENT**

**Burlington High School  
123 Cambridge Street  
Burlington, Massachusetts**

Prepared by:  
Massachusetts Department of Public Health  
Center for Environmental Health  
Emergency Response/Indoor Air Quality Program  
January 2006

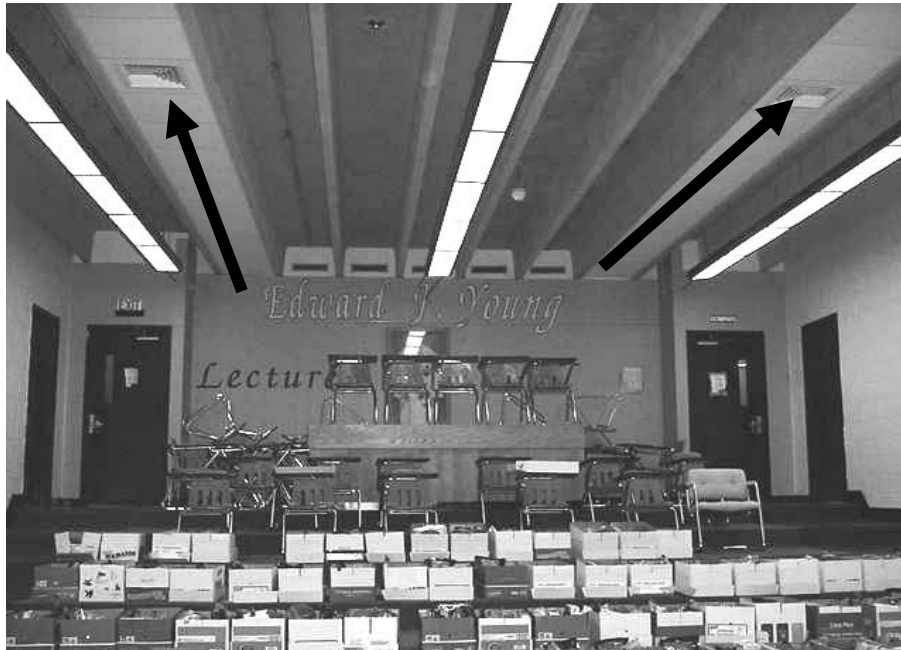
**Picture 7**

Fresh air is provided by air handling units (AHUs) located in rooftop penthouses (Picture 6). The AHUs are connected to ducts that were originally connected to wall-mounted air diffusers. Each of these diffusers were installed in the space between the interior wall and roof decking, in essence directing air down the channel created by the roof deck. Ducted exhaust vents were also installed in this manner, side by side with the fresh air supplies. This configuration likely created the condition of short circuiting, where fresh air delivered to a classroom is readily drawn back into an exhaust vent with minimal mixing in the room. In an effort to improve air mixing in classrooms, the supply vents were extended, which now terminate at a four-way, ceiling-mounted, fresh air supply diffuser (Picture 7).

**Retrofitted Fresh Air Supply Vents in Classroom**

of Finance and Operations, Burlington Public Schools, the HVAC system was last balanced when the fresh air diffusers were extended several years ago. It is recommended that existing ventilation systems be re-balanced every five years to ensure adequate air systems function (SMACNA, 1994).

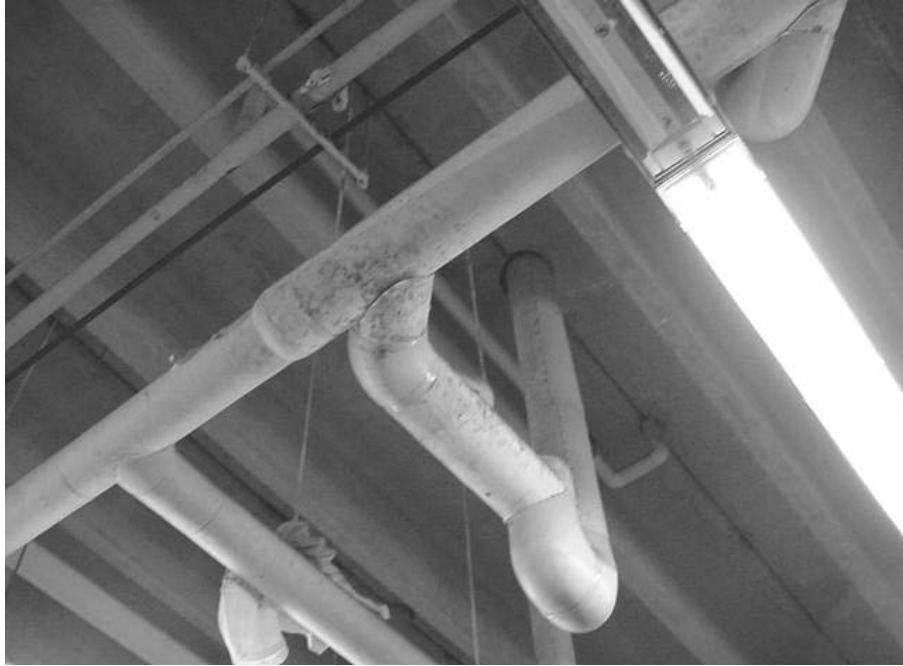
**Picture 8**

**Water Damaged Pipe Insulation in Locker Room**

1. Replace/repair any remaining water-stained ceiling tiles and building materials.  
Examine the area above and around these areas for mold growth. Disinfect areas of water leaks with an appropriate antimicrobial.
2. Discontinue use of pottery kilns until adequate exhaust ventilation can be installed.
3. Seal all vents that are part of the general HVAC system that exist in the kiln room.
4. Do not recycle clay until appropriate exhaust ventilation or provision of personal protective equipment is acquired.

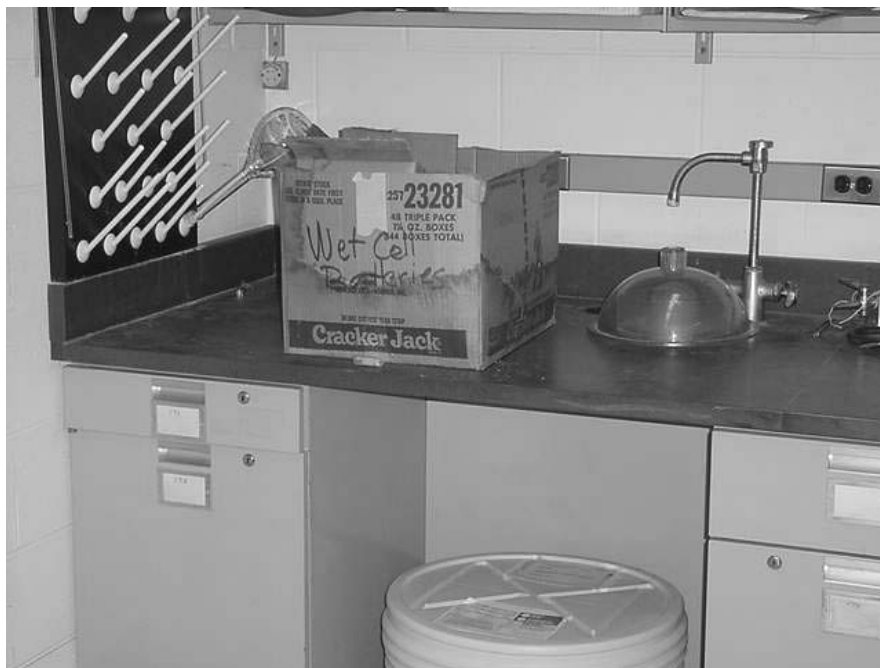
**Picture 9**

**Water Damaged Box, Science Prep Area**

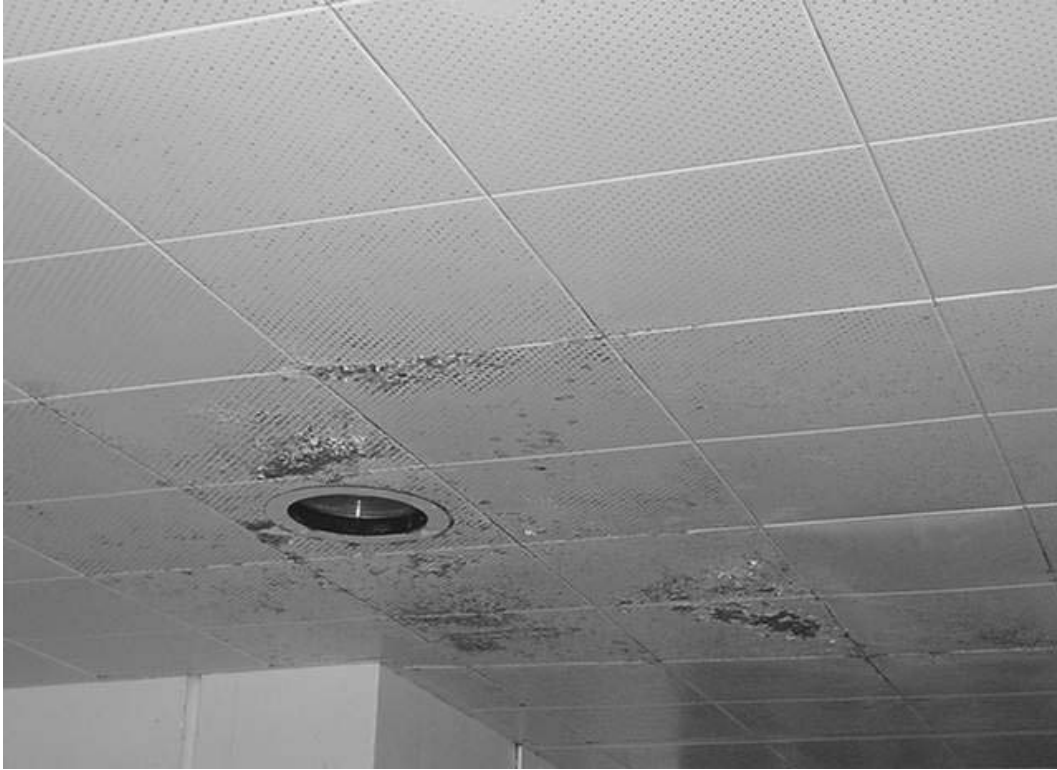
**Picture 10**

Water damaged ceiling tiles were observed in a number of classrooms. While the ceiling tiles did not appear to be colonized with mold, water damaged ceiling tiles should be replaced. As reported by BHS faculty, a number of hallway areas have leaks during rainstorms where containers are used to capture water. Water damaged pipe insulation was observed in the boy's locker room (Picture 8). A number of water damaged boxes were located in the science room (Picture 9) and a number of hallway areas had water damage, producing rust (Picture 10). As denoted in the previous MDPH IAQ assessment, leaks from the roof/flashing would accumulate on top of the metal suspended ceiling, creating rusting. Water damaged carpeting was also noted in an office area off of the main library area (Picture 11).

**Water Damaged Ceiling System, Hallway**

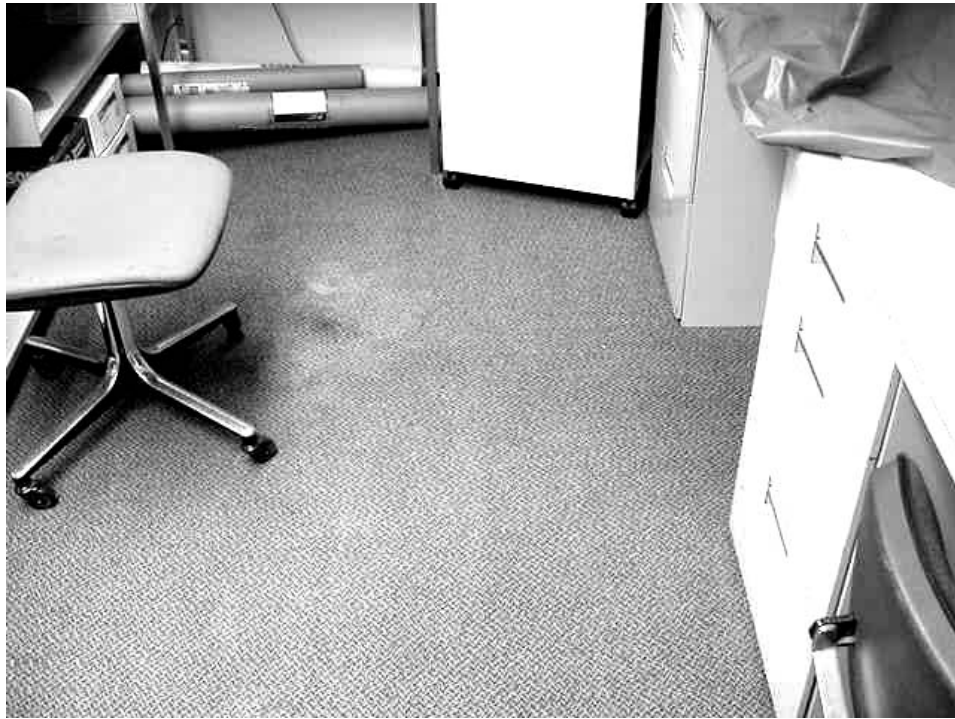
**Picture 11**

**Water Damaged Carpet**

5. Repair all damaged GW and seal the hallway ceiling plenum from classrooms. Do not use fibrous ceiling tiles as repair materials.
6. Remove water damaged carpeting in a manner consistent with recommendations found in “Mold Remediation in Schools and Commercial Buildings” published by the US Environmental Protection Agency (US EPA, 2001). Consider replacing carpeting with a non-slip, nonporous material (e.g., rubber matting, tile).

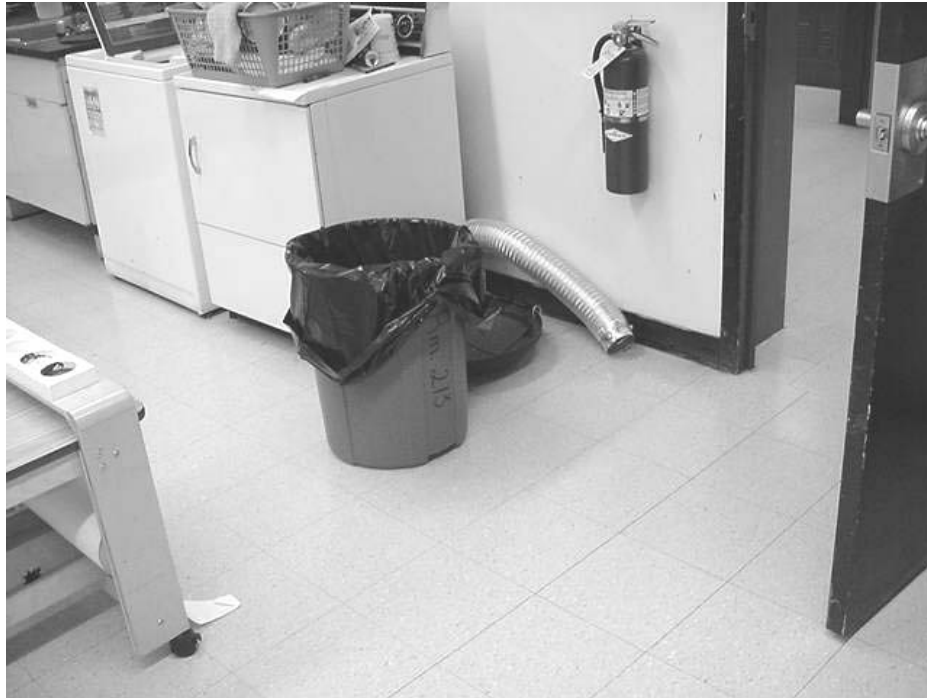
**Picture 12**

Two unvented clothes dryers were observed in room 375 (Nutrition), which results in dryer exhaust pollutants being vented into the classroom (Picture 12). Dryers should be vented to the outside of the building. Clothing dryers are a source of water vapor, lint and dusts which can be irritating to certain individuals. Of note were vents in the ceiling of the home economics rooms found open to the outdoors that may have previously been used as dryer exhaust vents (Pictures 13 and 14). Open vents to the outdoors can be a source of unconditioned air and moisture in summer months.

**Dryer Venting Into Classroom**

9. Evaluate all restroom exhaust vents for function and repair as needed.
10. Connect the clothes dryers to the appropriate ceiling vents.
11. Examine all rooftop AHU filters monthly for proper installation.

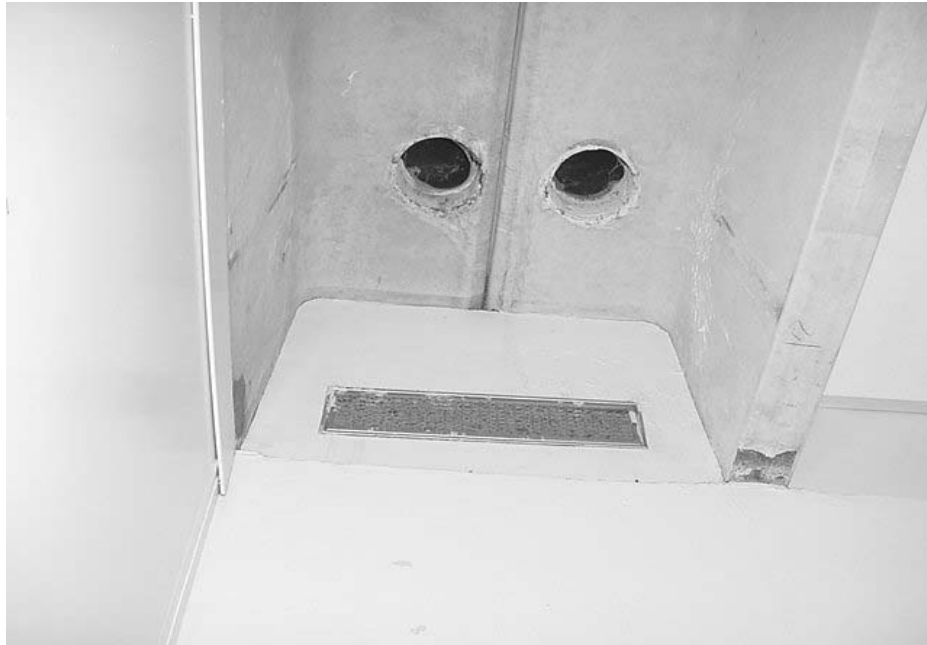
**Picture 13**

**Abandoned Dryer Vents**

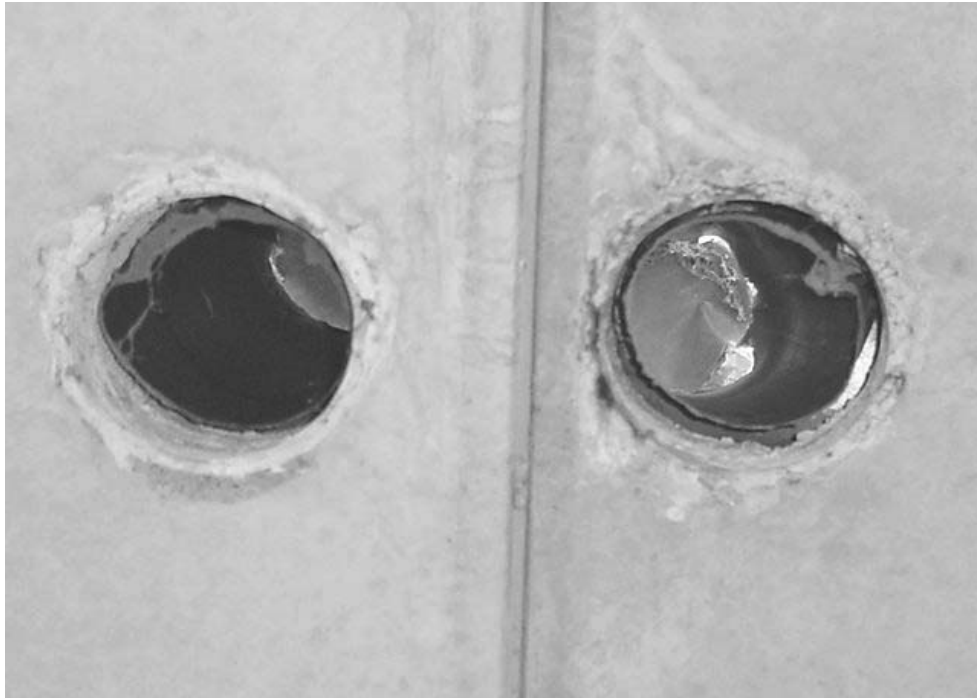
**Picture 14**

**Close-Up of Abandoned Dryer Vents, Note Light**

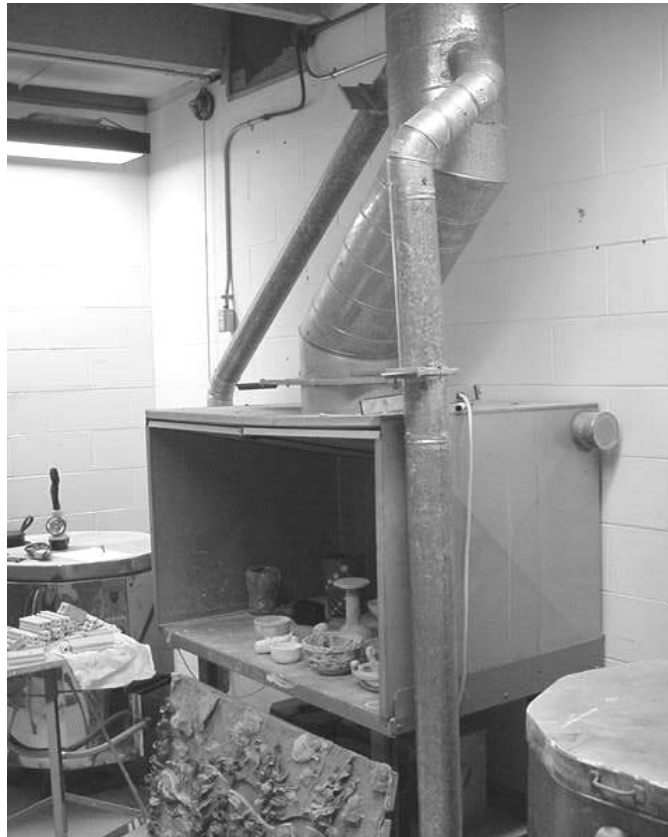
**Picture 15**

A number of other conditions that can potentially affect indoor air quality were seen during the assessment. The art department uses kilns to fire pottery (Picture 15). Each kiln is connected into a common vent with a spray booth in the kiln room. In this configuration, it is possible that pollutants produced during kiln operation migrate through the spray booth into the kiln room. Of concern is the presence of the kiln room exhaust vents that are likely part of the general HVAC system (Picture 16). The best practice for ventilation of kilns is to have each kiln connected to a separate dedicated exhaust vent. In addition, the possibility of fire exists if a flammable material is used in the spray booth while a kiln is operating. Kiln pollutants such as waste heat, clay particles and glaze components need to be vented outdoors.

**Pottery Kilns and Spray Booth with Shared Exhaust Vent Ducts**

1. Continue with plans to repair the roof.
2. Examine the feasibility of removing the hallway ceiling system. Consider replacement with a conventional ceiling system.
3. Install separate exhaust vents for each kiln.
4. Consider moving the spray booth to an exterior wall and use for clay recycling.

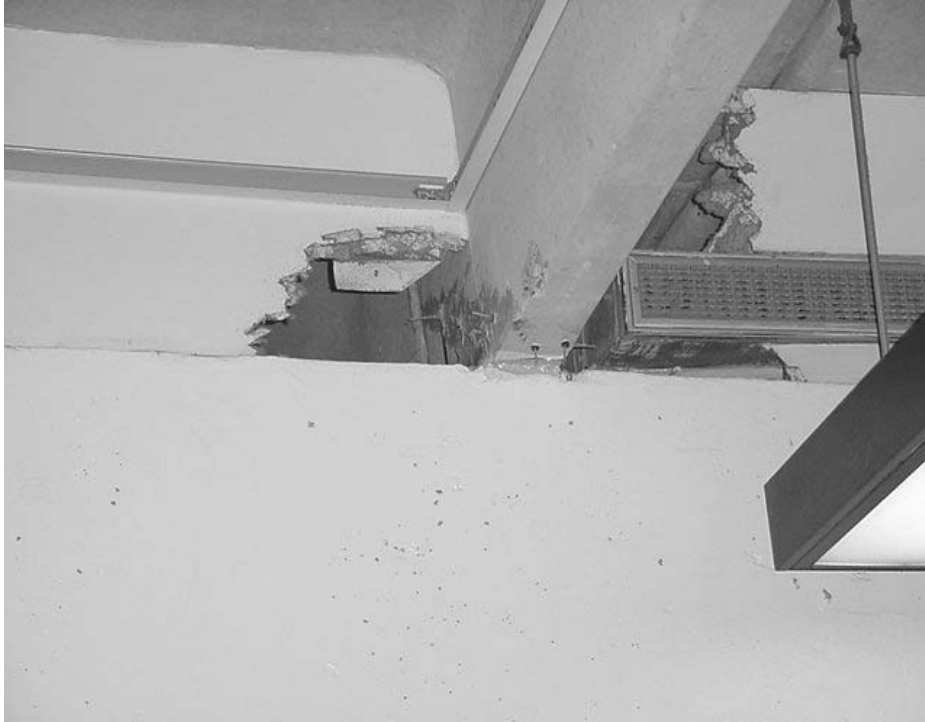
**Picture 17**

classroom interior hallway wall and ceiling. The GW serves as the separation for the classroom interior and ceiling plenum above the hallway suspended ceiling. In a number of classrooms, the GW was damaged (Picture 17), missing (Picture 18) or repaired by inserting ceiling tiles cut to size (Picture 19). In this condition, air from the hallway plenum may migrate into the classrooms through these breaches. As discussed previously, the hallway ceiling system is likely to have significant accumulation of dust and other debris that has settled on top of the fiberglass insulation packets. Areas outside the heating/air-conditioned space (e.g., ceiling plenums) should be separated from occupied areas.

**Damaged Gypsum Wallboard**

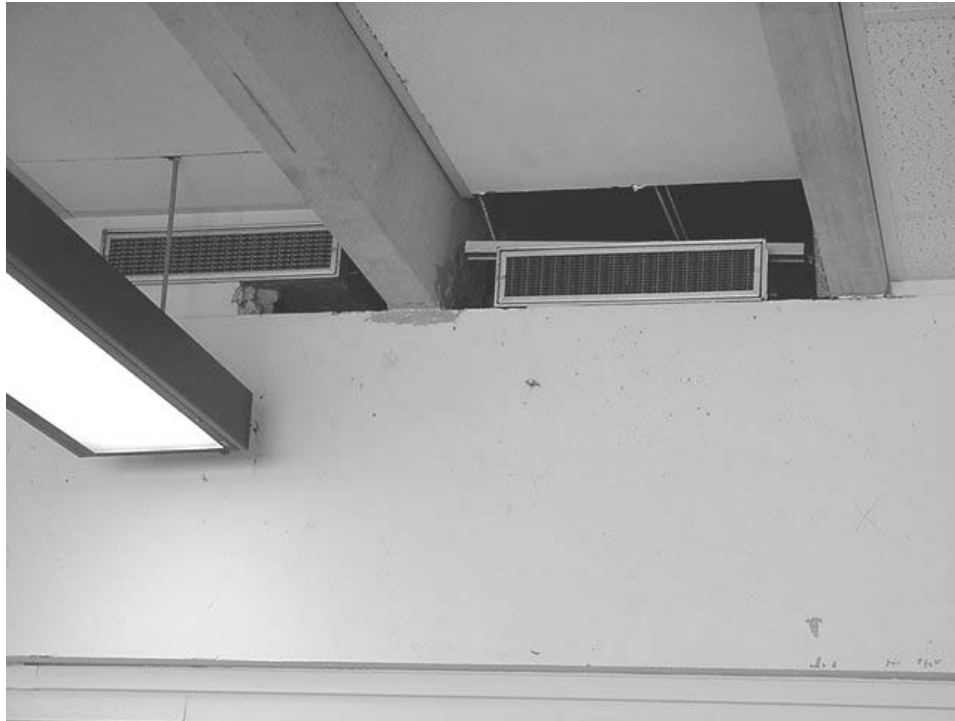
**Picture 18**

**Missing Sections of Gypsum Wallboard**

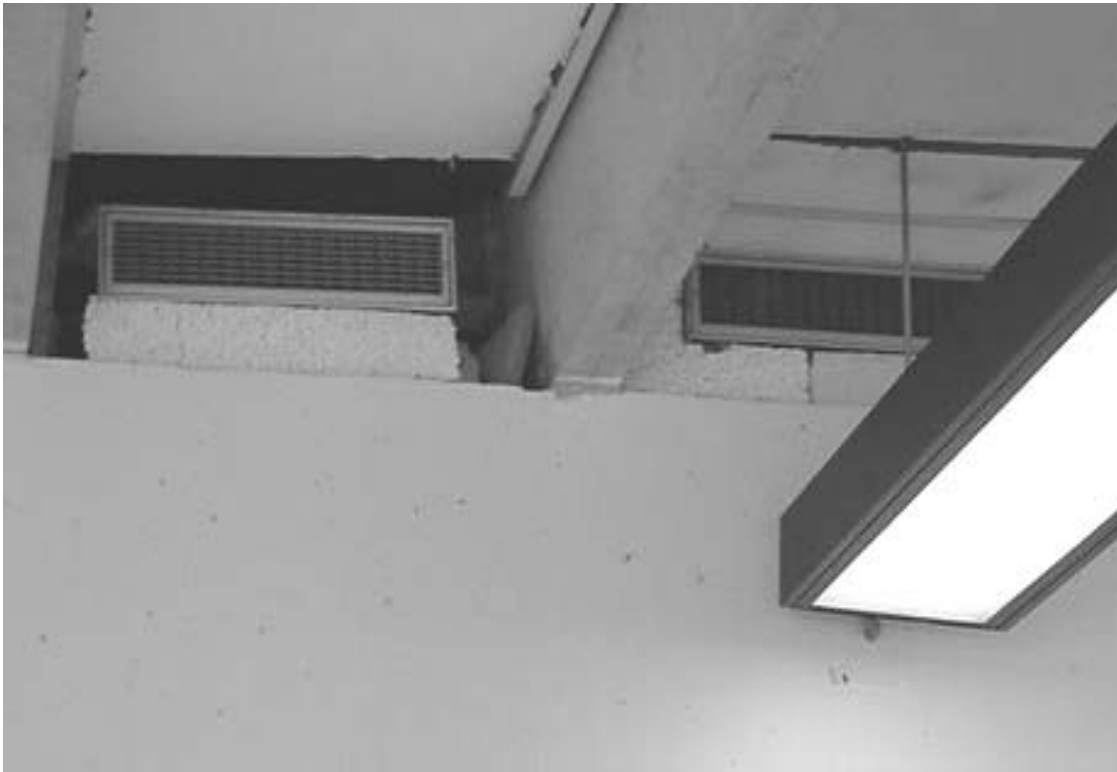
**Picture 19**

**Gypsum Wallboard Repaired Using Ceiling Tile**

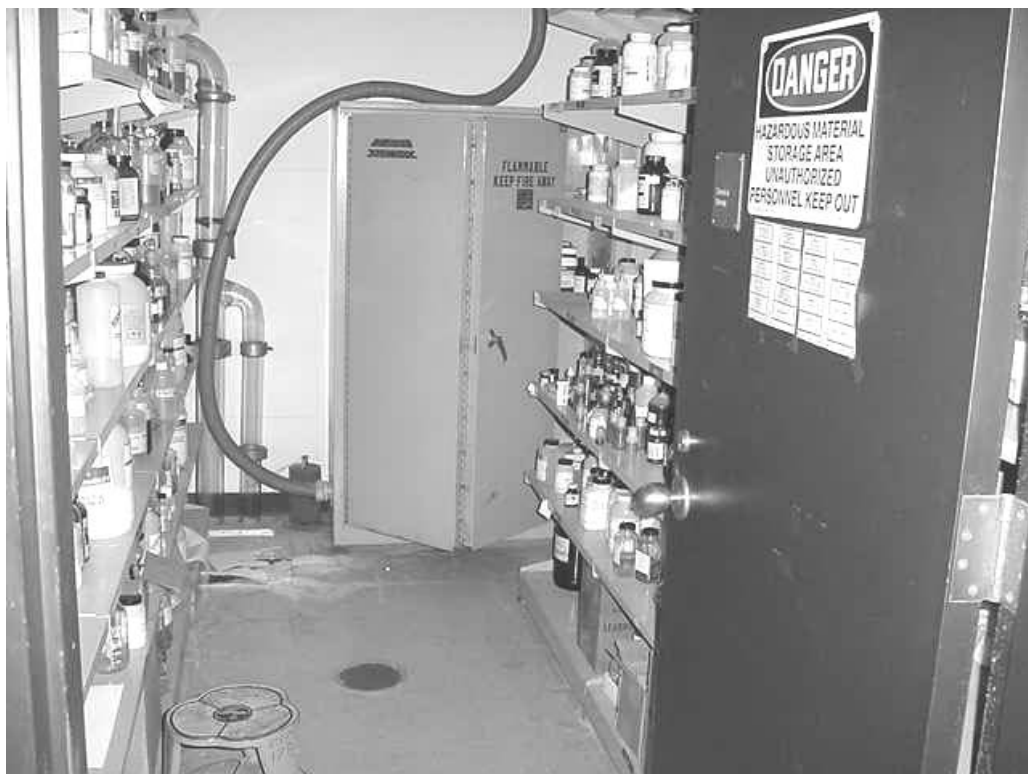
**Picture 20**

Also of note is the condition of the flameproof cabinet in the chemical storeroom. A selection of flammable materials were stored within this cabinet. The bung-hole covers were removed from the cabinet (Picture 20) and a flexible hose was connected to a vent in the ceiling (Picture 21). If flameproof cabinets are to be vented, the installation of the exhaust system must be equipped in a manner to prevent backflow. The National Fire Prevention Association (NFPA) does not require venting in flammable storage cabinets, however, if venting is done, it must be vented directly outdoors and in a manner not to compromise the specific performance of the cabinet (NFPA, 1996). In this configuration, it would not be expected that the cabinet would perform as designed in the case of a fire.

**Flameproof Cabinet, Note Hose**

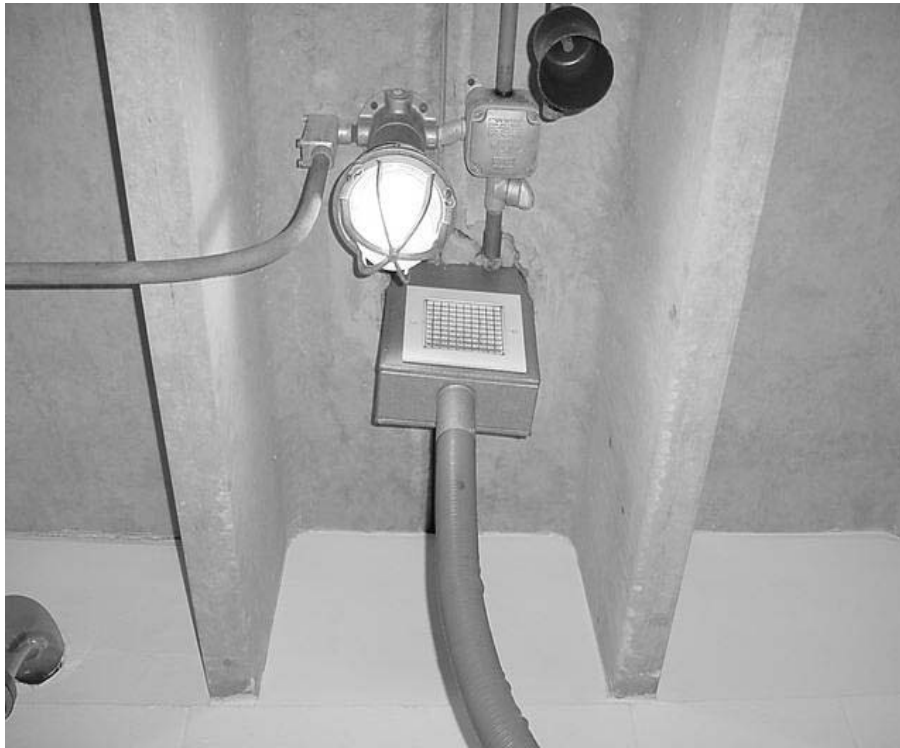
**Picture 21**

**Vent Connected to Flameproof Cabinet**

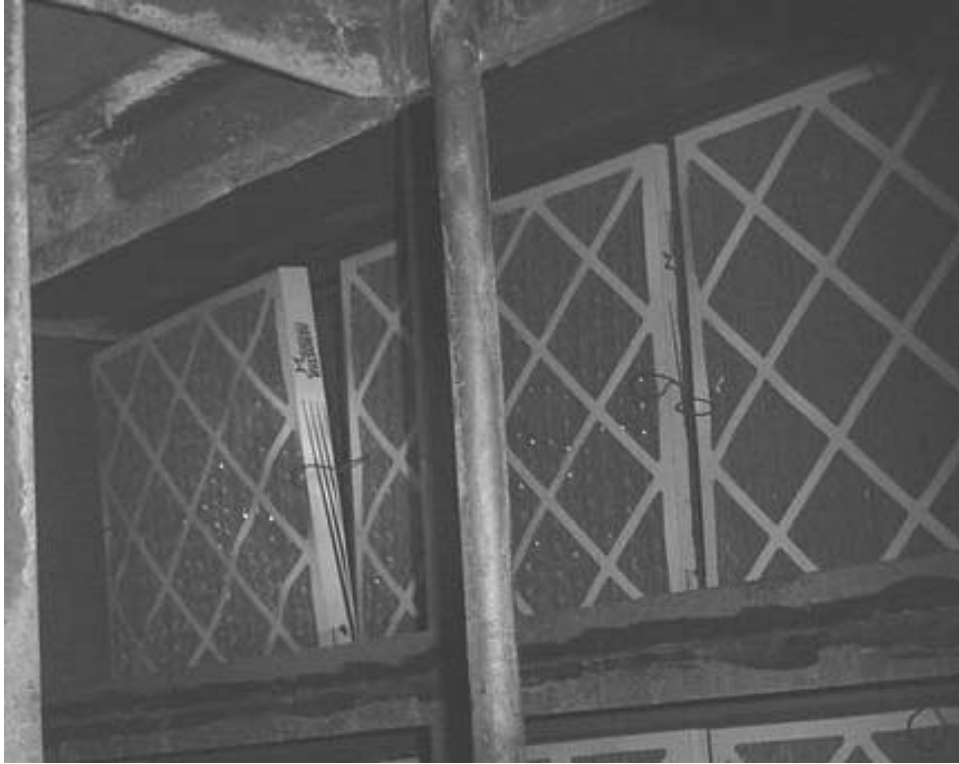
**Picture 22**

AHUs are normally equipped with filters that strain particulates from airflow. A bank of high-efficiency pleated air filters is installed inside each rooftop AHU. During a spot check of this equipment, one filter had become ajar, therefore creating a breach in this filter bank (Picture 22). In this condition, air can by-pass the filters and enter the building. Filter banks should have filters that are installed in a manner to prevent air bypass.

**Filter Bank in AHU, Note Ajar Filter**
